Manhole Inspection Summary

Manhole # S15GG1032MH

Insp Date: **6/18/07 12:18 PM**

Location Address: **2600 PARK HEIGHTS TER** Cross Street: **PALL MALL RD**

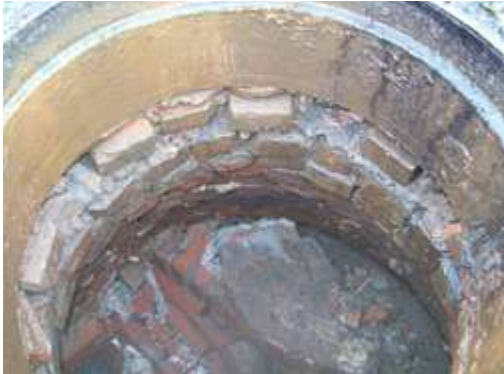
Defect 3

DEBRIS ON BENCH AND CHANNEL

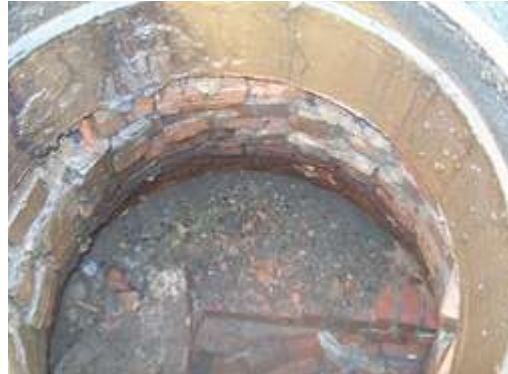
Defect 2

Condition: ☐ Sound ☒ **Cracked** ☐ Root Intrusion ☒ **Deteriorated** ☐ Leaks ☐ Debris

CRACKED AND DETERIORATED OF BENCH

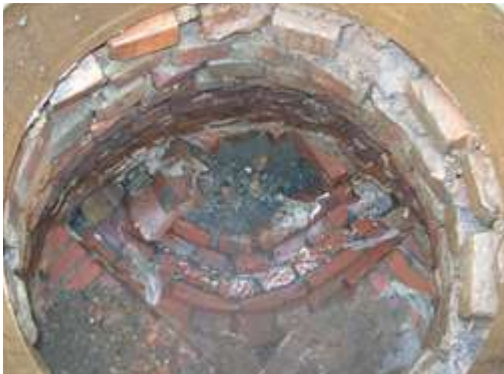
Defect 1

Condition: ☐ Sound ☐ Cracked ☐ Root Intrusion ☐ Loose Brick ☒ **Deteriorated**

DETERIORATED OF CORBEL AND BARREL

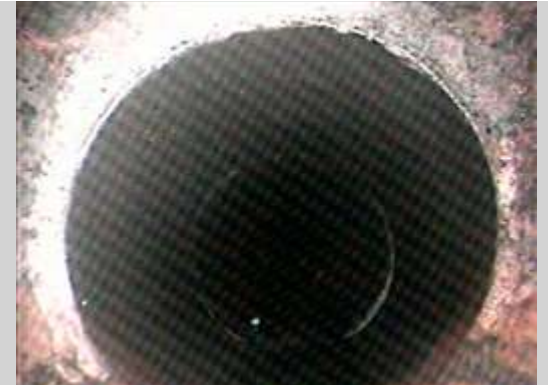
12 O'Clock Outflow

8 in. Circular Gravity Sewer
Pipe Out @ 12 O'Clock

Pipe Height: (in.) Direct
Pipe Material: **Clay** ☐ Pipe Lined
Invert Depth: **4.34** (ft.) Flow Characteristics: **Slow**
Deposits: ☐ None ☐ Mud ☐ Sludge ☒ **Debris** ☐ Grease
Silt Depth: **3** (in.) Deposits Extent: **Medium**
Infiltration: **None** Pipe Seal Cond: **Unknown**

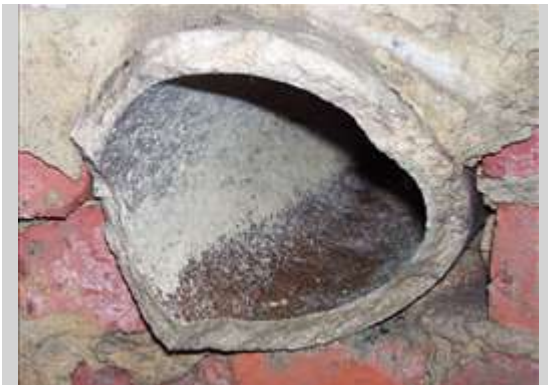
3 O'Clock Inflow

8 in. Circular Gravity Sewer
Pipe In @ 3 O'Clock

Pipe Height: (in.) Direct
Pipe Material: **Clay** ☐ Pipe Lined
Invert Depth: **4.28** (ft.) Flow Characteristics: **Slow**
Deposits: ☒ **None** ☐ Mud ☐ Sludge ☐ Debris ☐ Grease
Silt Depth: (in.) Deposits Extent:
Infiltration: **None** Pipe Seal Cond: **Broken**
